ROCKETBORNE LASER BACKSCATTER EXPERIMENT

O. Shepherd  
A. G. Hurd  
W. H. Sheehan  
R. D. Bucknam

15 March 1979

Final Report: 6 May 1976 — 15 February 1979

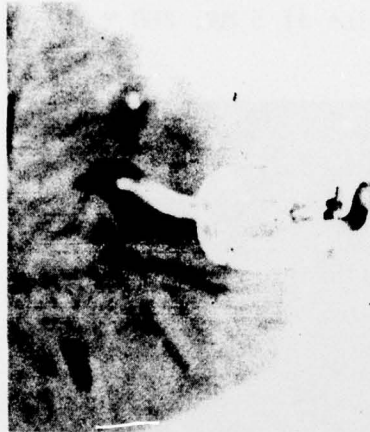
The glass was scribed and broken to reveal the inner structure of the diode. Figure 5 presents the "S" strap end of the diode.

FIGURE 5: "S" STRAP OF THE DIODE (4X)

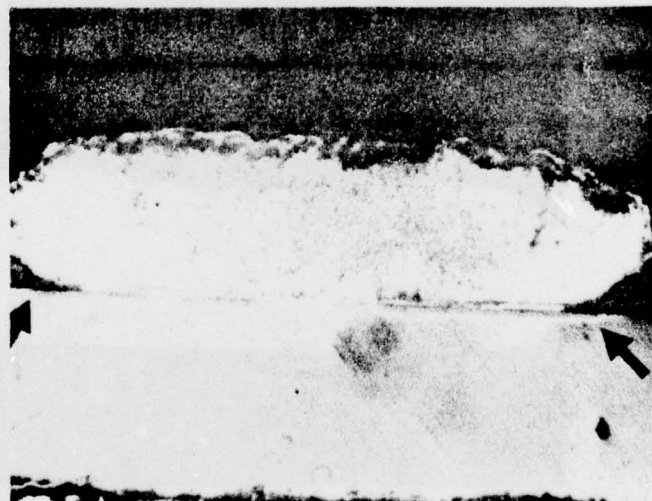
The oval shape at the top is the silver button contact, the parallelogram shape is the silicon chip which is soldered to the post. At higher magnifications the P/N junction is visible (arrows) after staining as in Figure 8.

FIGURE 8: STAINED DIODE JUNCTION (300X)

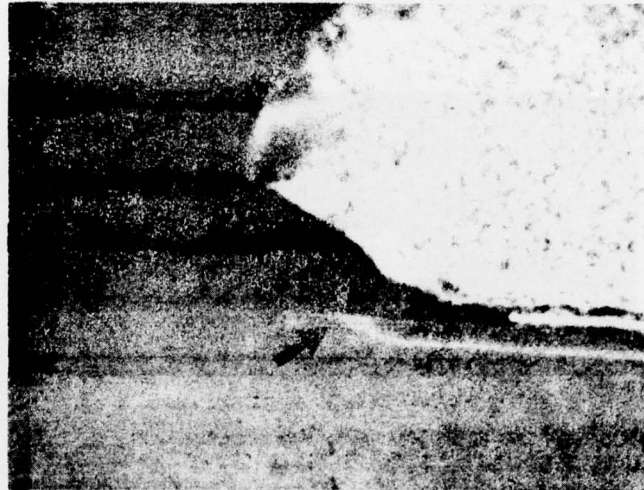
Cross-sectioning was continued until damage at the periphery of the junction was located (Figure 9).

FIGURE 9: DAMAGE AT JUNCTION EDGE (800X)

The damage indicates a possible transient voltage overstress but would not explain the low resistance short that was previously measured. Cross-sectioning was continued until evidence of general junction degradation was seen as in Figure 10. At higher magnification (Figure 11) a moving diffusion is evident.

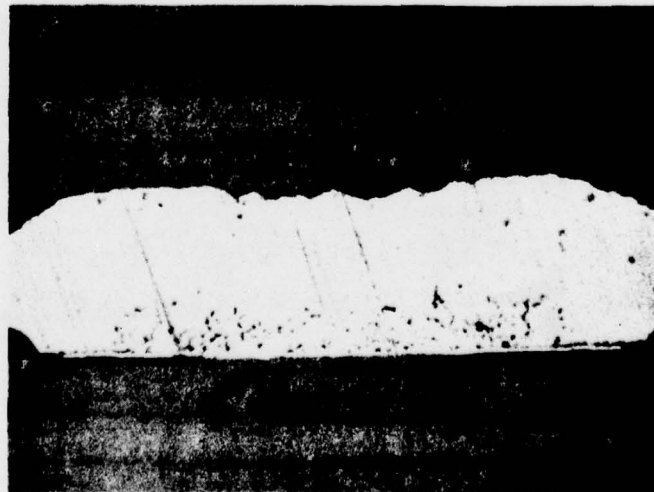
FIGURE 10: JUNCTION DEGRADATION REVEALED BY STAIN (300X)

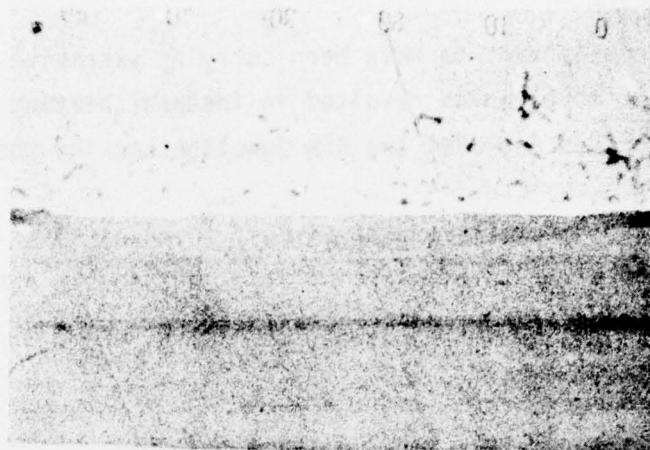
FIGURE 11: JUNCTION DEGRADATION BY DIFFUSION (600X)
